# RADIOGRAPHIC DETECTION AND CHARACTERISTIC PATTERNS OF RESIDUAL EXCESS CEMENT ASSOCIATED WITH CEMENT-RETAINED IMPLANT RESTORATIONS: A CLINICAL REPORT

**Chandur Wadhvani, BDS, MSD,<sup>a</sup> Darrin Rapoport, BDS, MSD,<sup>b</sup> Silvia La Rosa, DDS,<sup>c</sup> Timothy Hess, DDS,<sup>d</sup> and Stefanie Kretschmar, Dr med dent, MSD<sup>e</sup>**  
University of Washington, Seattle, Wash

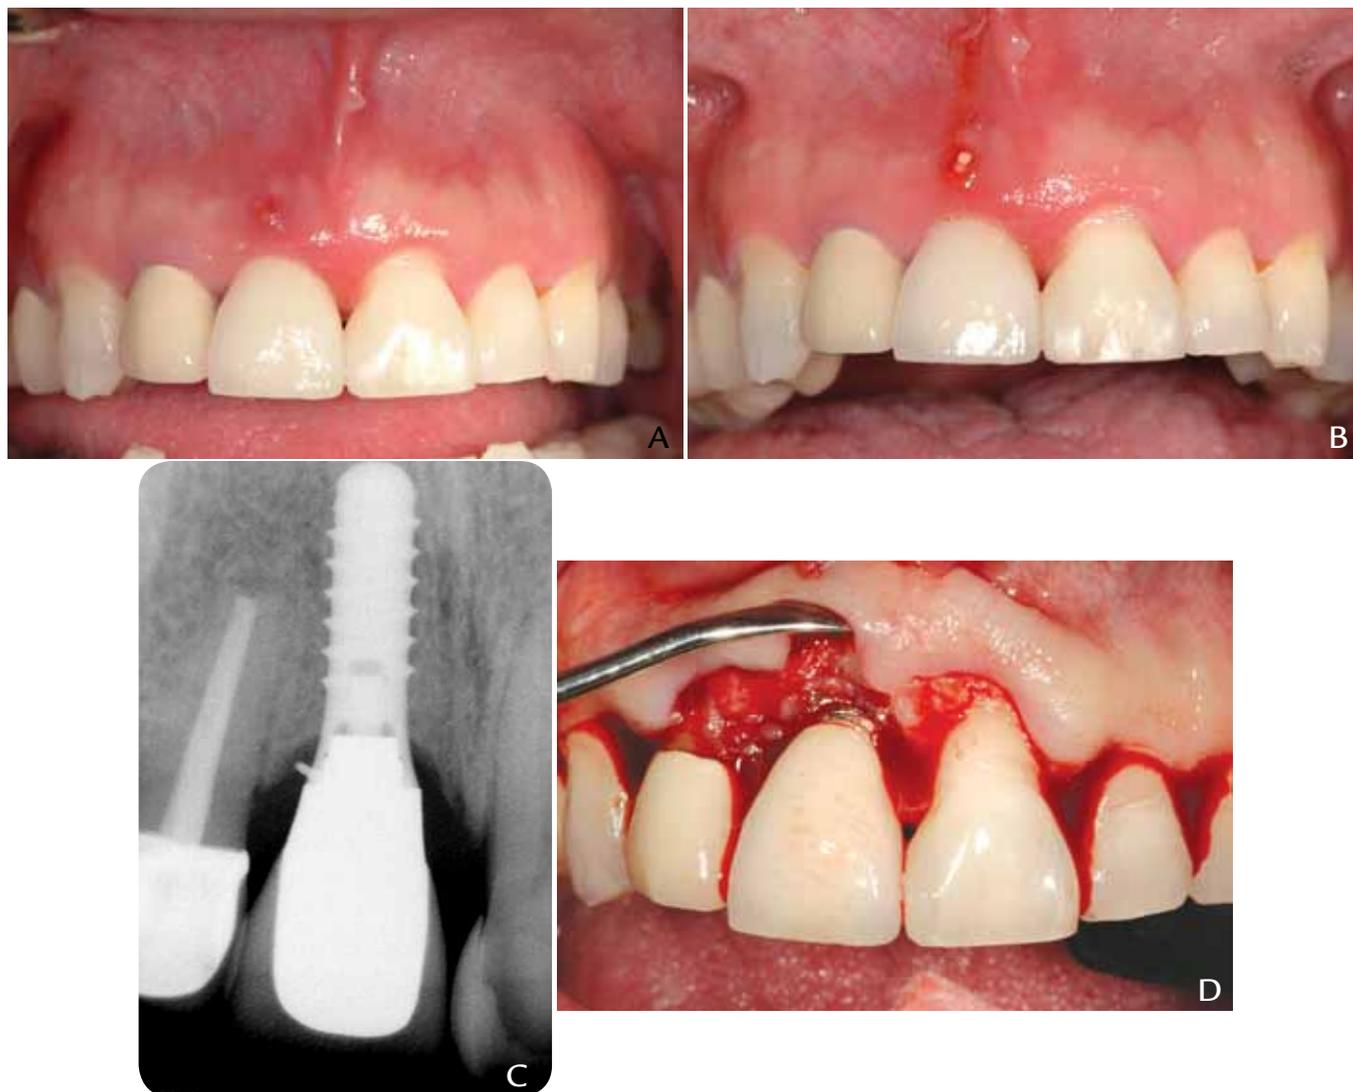
Seven months after completion of the restoration, the patient presented with a draining sinus tract on the midfacial aspect of the implant site (Fig. 1A). A size 20 ISO gutta percha point (Henry Schein, Melville, NY) was placed into the sinus tract (Fig. 1B), and a radiograph was made. The gutta percha point terminated at the

**1** A, Seven months post cementation of implant crown. B, Gutta percha point placed into sinus tract. C, Radiograph, gutta percha point visible. D, Full thickness flap raised, exposing cement residue.

abutment/crown interface (Fig. 1C). Initial nonsurgical attempts to debride the site under local anesthesia were unsuccessful, and it was decided to treat the area surgically. Full thickness facial and lingual flaps were elevated to reveal residual subgingival REC deposits at the crown/abutment interface (Fig. 1D). The REC was located predominantly on the facial aspect, such that the superimposition of the cement on the metal implant components rendered the cement almost impossible to detect radiographically.

The residual cement was removed with hand scalers, (Implacare tip curettes: Columbia 4r/4l, 204s, h6/h7; Hu-Friedy, Chicago, Ill) taking care to avoid damaging the implant sur-

face. An autogenous connective tissue graft was harvested from the right palatal vault area and secured over the facial aspect of the implant. The sinus tract resolved completely within 6 months, and the patient was placed on a 4 month interval recall program, including probing depth monitoring and annual radiographs.

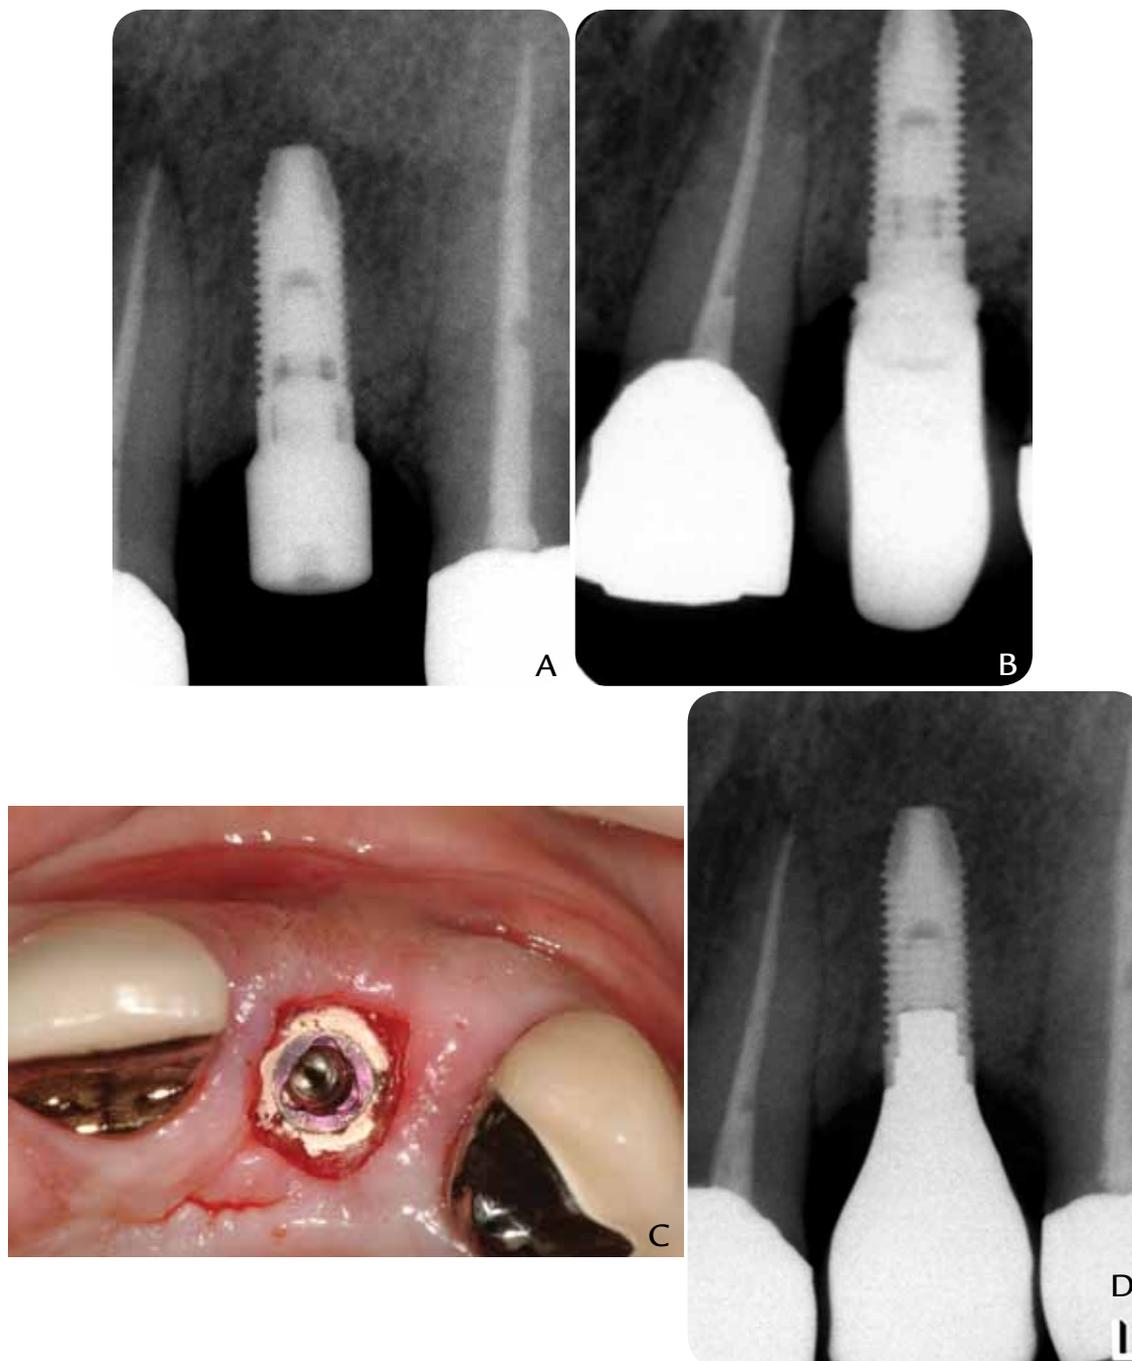
**2** A, Prerestoration radiograph. Implant considered integrated. B, Post insertion radiograph. Restoration with radiopacity noted. C, Crown and abutment removed, cement encircling abutment visible. D, Post treatment radiograph, note replacement with screw-retained restoration.

definitive treatment. One week after the definitive restoration was placed, the patient returned for a soft tissue and radiographic post restoration evaluation. The soft tissue appeared pale pink with no signs of inflammation. However, a radiograph revealed the presence of REC (Fig. 2B). On removing the crown and the abutment, the implant platform was found to be encircled by cement (Fig. 2C), which

was subsequently removed. A new healing abutment was placed, and the restoring dentist was asked to reconsider the restorative options available. Because the implant position was favorable, the subsequent restoration was screw-retained (Fig. 2D), which eliminated the issues associated with cement. The patient was then provided with supportive periodontal therapy and annual implant assessment

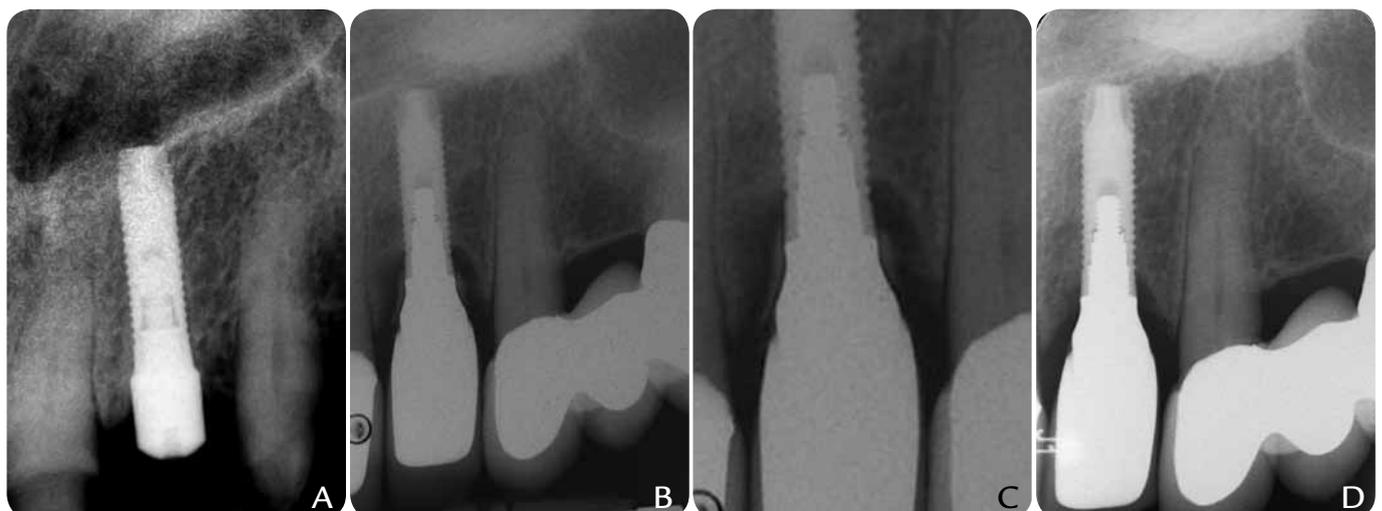
**3** A, Prerestoration radiograph of implant. B, Radiograph indicating “peripheral egg shell” effect—(layer of REC). C, Magnified view of 3B. D, Post treatment radiograph with cement removed.

The radiograph relating to patient 3 also indicates the crown failed to seat completely, leaving a margin that would have allowed greater excess cement to be extruded during placement. This may have occurred because of too much cement within the crown, tight proximal contact, tight fit of the crown, inadequate cement space, not following cement manufacturer recommendations regarding working and setting time, or inadequate pressure application while seating the crown. Some of these issues

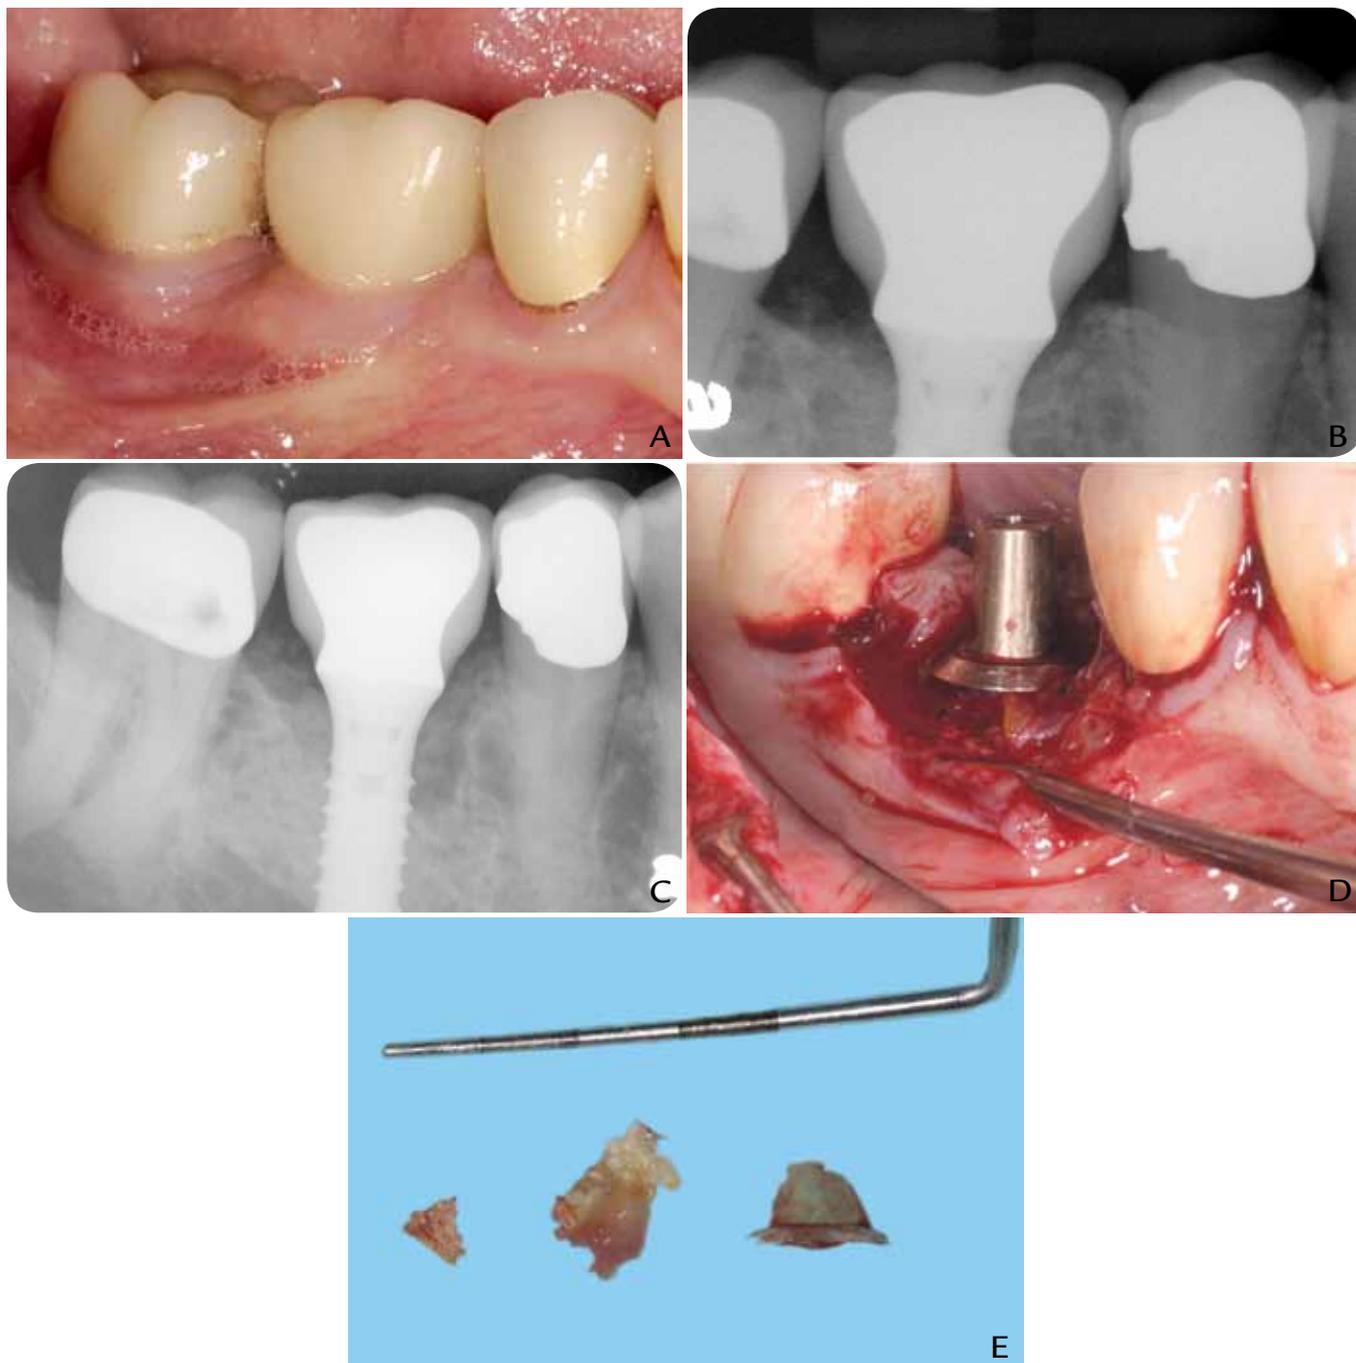
**4** A, Post insertion photograph of implant placed in mandibular right first molar site. B, Fourteen months post restoration radiograph, no evidence of bone loss around implant. C, Thirty-two months post insertion radiograph, bone loss evident, no indication of residual cement. D, Surgical exposure of REC. E, Cement remnants removed compared to periodontal probe with 3.

signs or symptoms of any pathological events. However, at 32 months, after completion of the restoration, clinical evidence of inflammation was noted. Bleeding on probing, an increase in periimplant probing depths, and a radiograph indicated bone loss associated with the implant (Fig. 4C). Treatment was initiated by removing the crown but leaving the stock abut-

ment in place. The periodontist prepared a full thickness flap to expose the residual REC circumferentially around the implant (Fig. 4D, 4E). Debridement of the inflammatory tissue was performed with both hand and ultrasonic instrumentation by using a piezoelectric unit (Piezon Master 600; Electro Medical Systems, Dallas, Texas) with a plastic coated im-

plant cleaning tip (PI, Piezon Implant Cleaning, Electro Medical Systems). The implant surface was treated with sterile saline (0.9% sodium chloride; Salvin Dental Specialties Inc, Charlotte, NC) before grafting the residual defect with an allograft material (Puros; Zimmer Dental Inc). This was followed by flap closure.

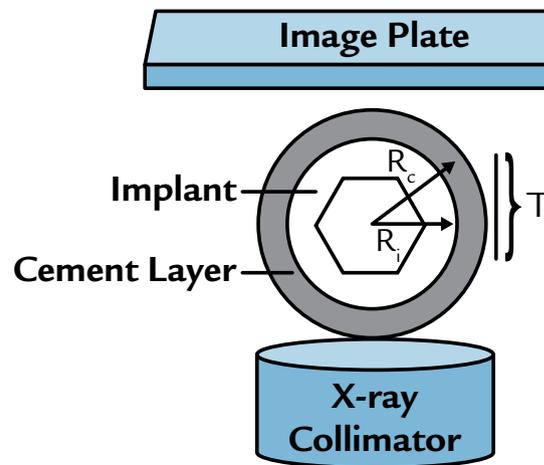
The site of extrusion may, under the right conditions of cement flow, enhance radiographic detection. Patient 3 is an example of a cement (resin modified glass ionomer) that is less radiopaque than a zinc cement, and that was detectable even though a minimal layer was used. This is because implants are generally circular in cross section, and when the cement flow follows this shape, a circumferential layer results. Because the radiographic beam passes tangentially through the thickness of the thin cement layer many times, an observed attenuation results (the peripheral egg-shell effect) (Fig. 5).<sup>9</sup>

**5** “Peripheral egg shell” effect, x-ray beam and radiographic plate are perpendicular to cement film, exposing increased thickness of cement. T: Tangential depth, Rc: Radius of implant plus cement, Ri: Radius of Implant. Calculation:  $T = 2\sqrt{R_c^2 - R_i^2}$ .
